9th Street Corridor Study

13th Avenue East to 12th Avenue Northeast
West Fargo, North Dakota

Final Report

March 2020

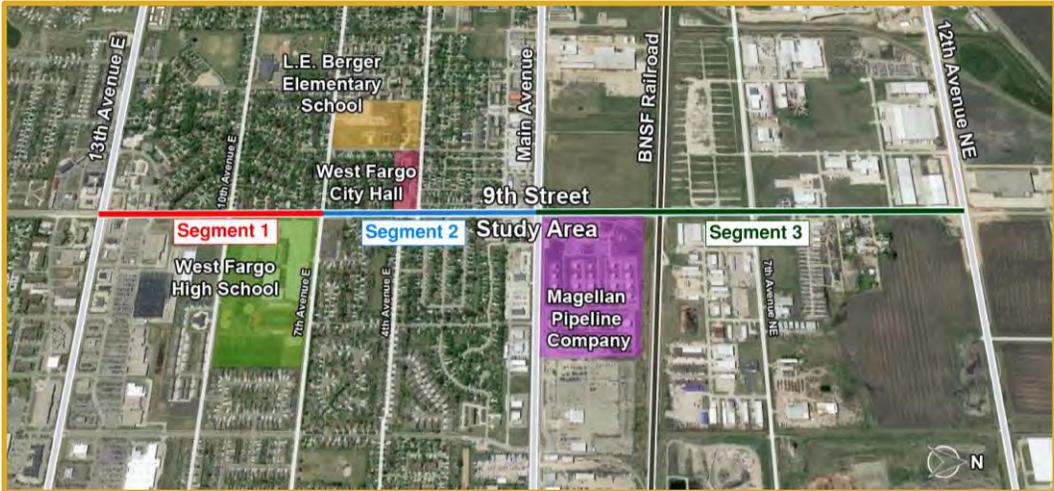
Figure 1.1: Study Location

9th Street is a north-south corridor through the City of West Fargo. South of Main Avenue, the corridor is a designated as 9th Street East and the corridor is designated as 9th Street Northeast on the north side of Main Avenue. **Both segments will be referred to as 9th Street for the purpose of this study.**

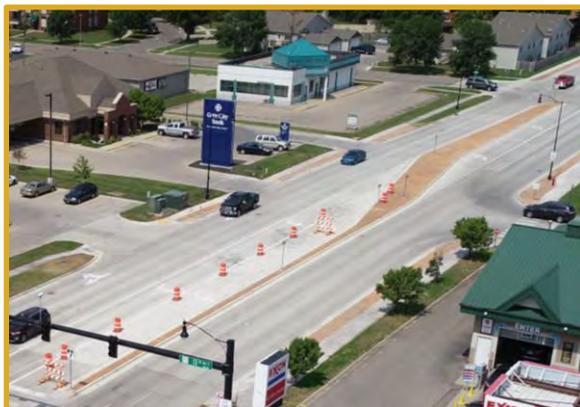
13th Avenue East to Meyer Boulevard | The existing pavement in this segment is concrete and in new condition. The 13th Avenue East to Meyer Boulevard segment was reconstructed in 2018. There are three driveways located in this section in new condition.

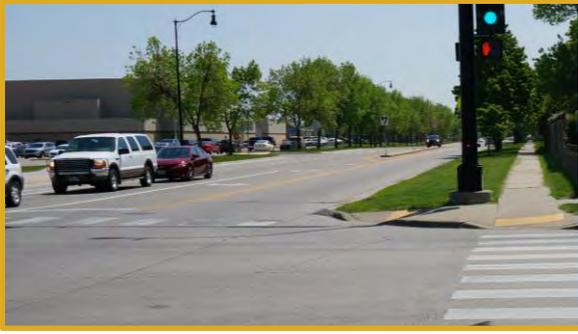
Meyer Boulevard to 7th Avenue East | The existing pavement in this segment is concrete. It is generally in average to below-average condition except for the easternmost northbound lane that was added in 2018 and is in new condition. There is one driveway located in this section in good condition.

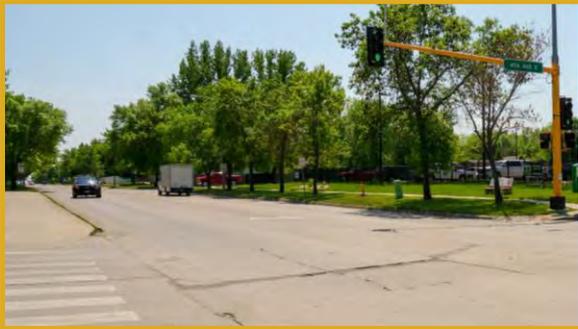
7th Avenue East to 1st Avenue East | The existing pavement in this section is concrete and was paved in 1997. It is generally in average to below-average condition, with areas of significant cracking and deterioration. There is one driveway located in this section in above average condition.

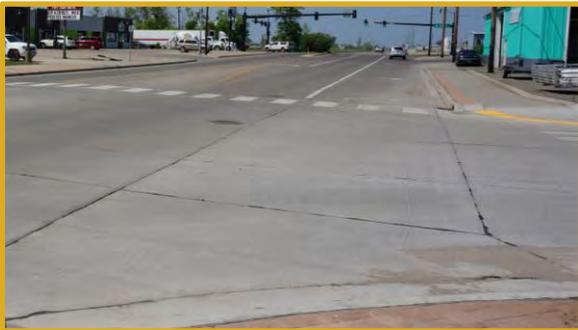
1st Avenue East to Main Avenue | The existing pavement in this section is concrete and was reconstructed in 2012. It is generally in above average to good condition. There are three driveways present in this section in good condition.

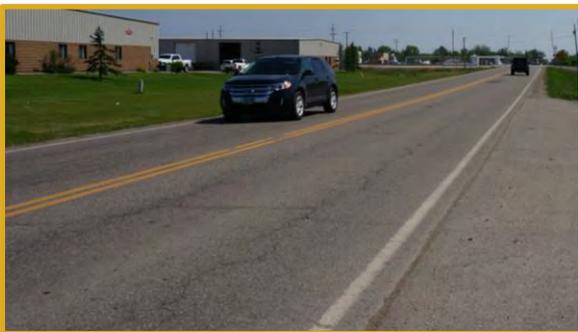
Main Avenue to 7th Avenue Northeast | The existing pavement in this section is asphalt with the exception of the 7th Avenue Northeast intersection. It is in below-average to poor condition, with areas throughout the stretch with particularly large longitudinal and lateral cracks in the asphalt. There are three driveways in this section of roadway in above average to good condition.

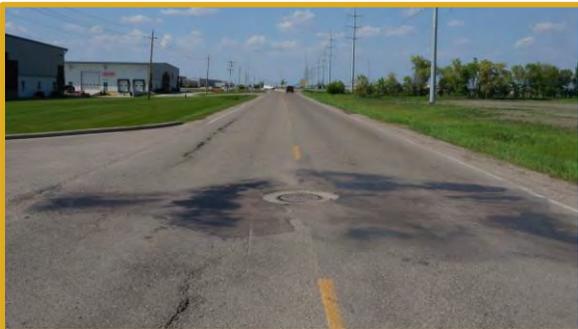
7th Avenue Northeast to 12th Avenue Northeast | The existing pavement in this section is asphalt. It is in poor to average condition, with areas throughout the stretch with some longitudinal and lateral cracks in the asphalt. There are 12 driveways in this section of roadway with concrete driveways in good condition while the gravel is poor to average condition.

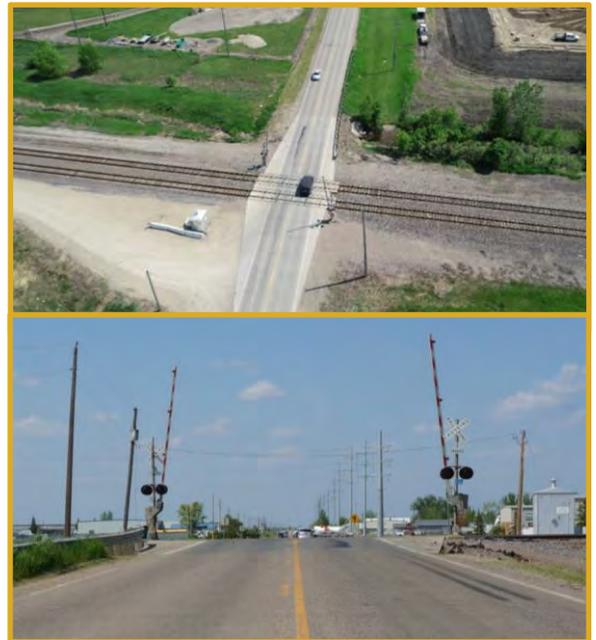
BNSF RR Crossing North of Main Street Intersection

There have been two accidents at this crossing since 2005, according to the data provided on the Federal Railroad Administration’s database. Of those two accidents, one resulted in a fatality.

The BNSF Railroad crossing north of Main Avenue should be considered for quiet zone improvements. With the addition of a path being installed on the west side of the tracks, quiet zone compliance could be implemented as a stand-alone project or as part of a larger project on 9th Street. This location has not been evaluated in a quiet zone study to date. Future improvements should be reflective of the increased pedestrian accessibility proposed on 9th Street.

The existing exposure factor (AADT X Trains/Day) for this crossing is over 280,000 and could increase to over 460,000 by the year 2045. The Federal Railroad Administration’s guidelines for grade separations indicate that a separation should be considered at an exposure factor of 250,000 for rural areas and 1,000,000 for urban areas. Given this crossing is in an industrial area, additional factors should be considered with a potential grade separation project. The 2045 Metropolitan Transportation Plan identified a long-term (2036-2045) grade separation project for this crossing with an estimated future cost of \$45,480,000 (approximately \$20,000,000 in 2020 dollars).

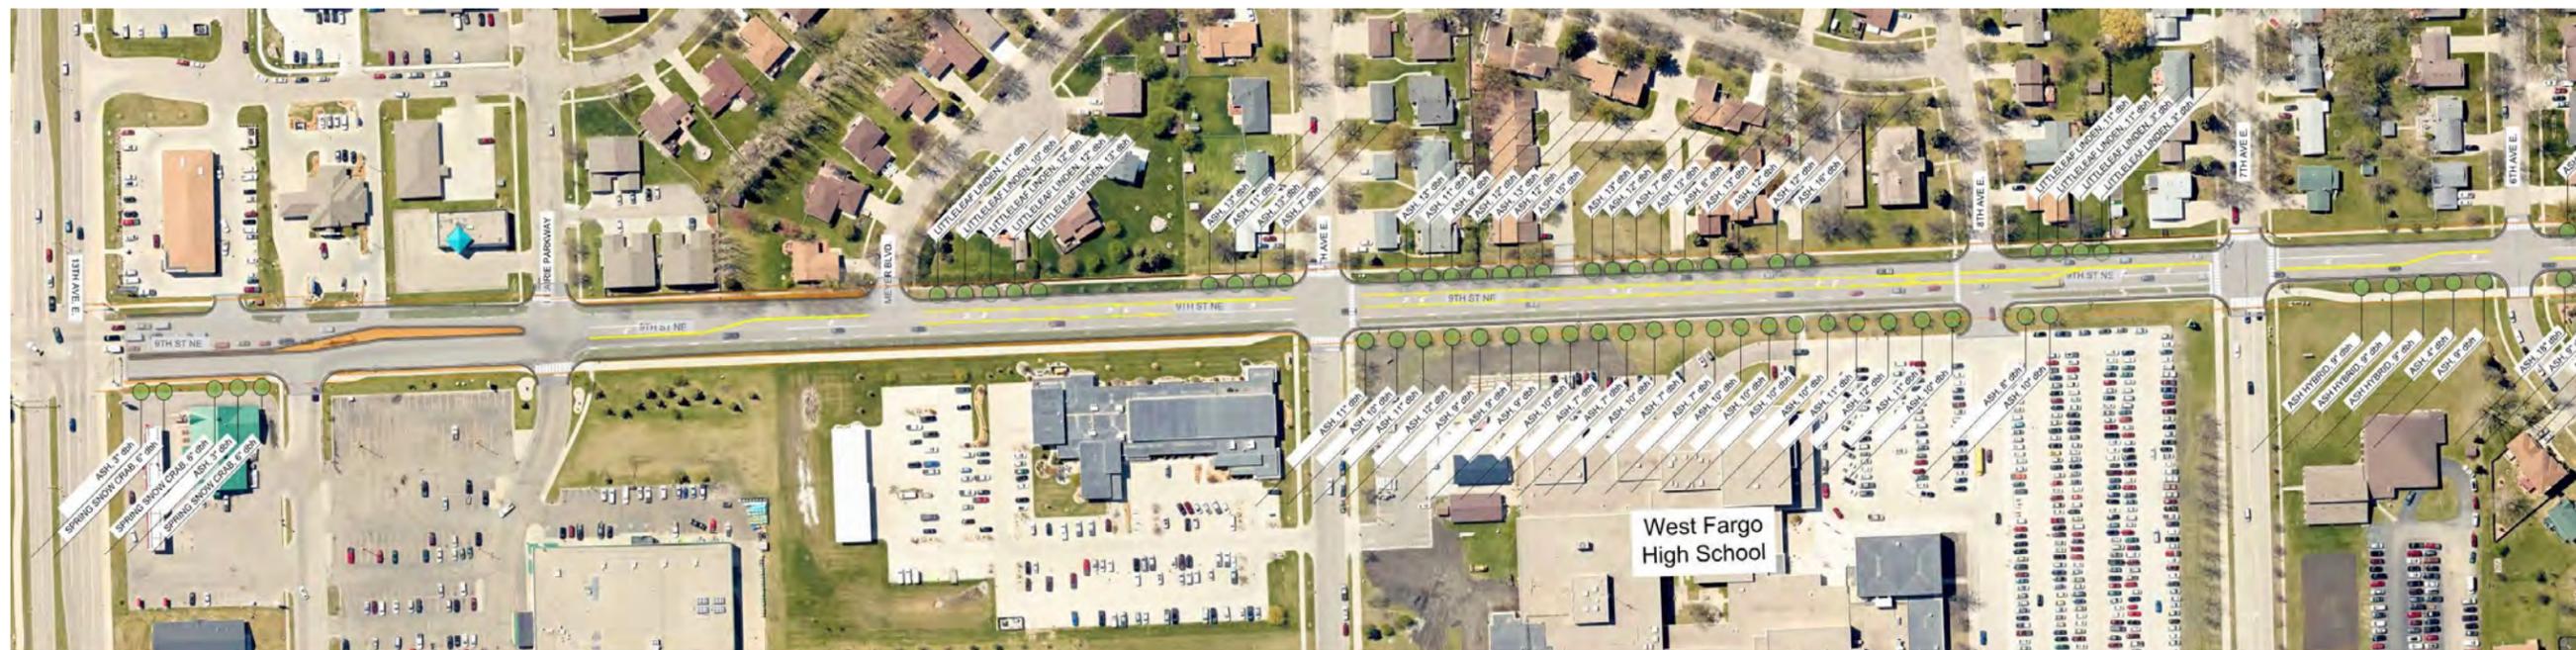
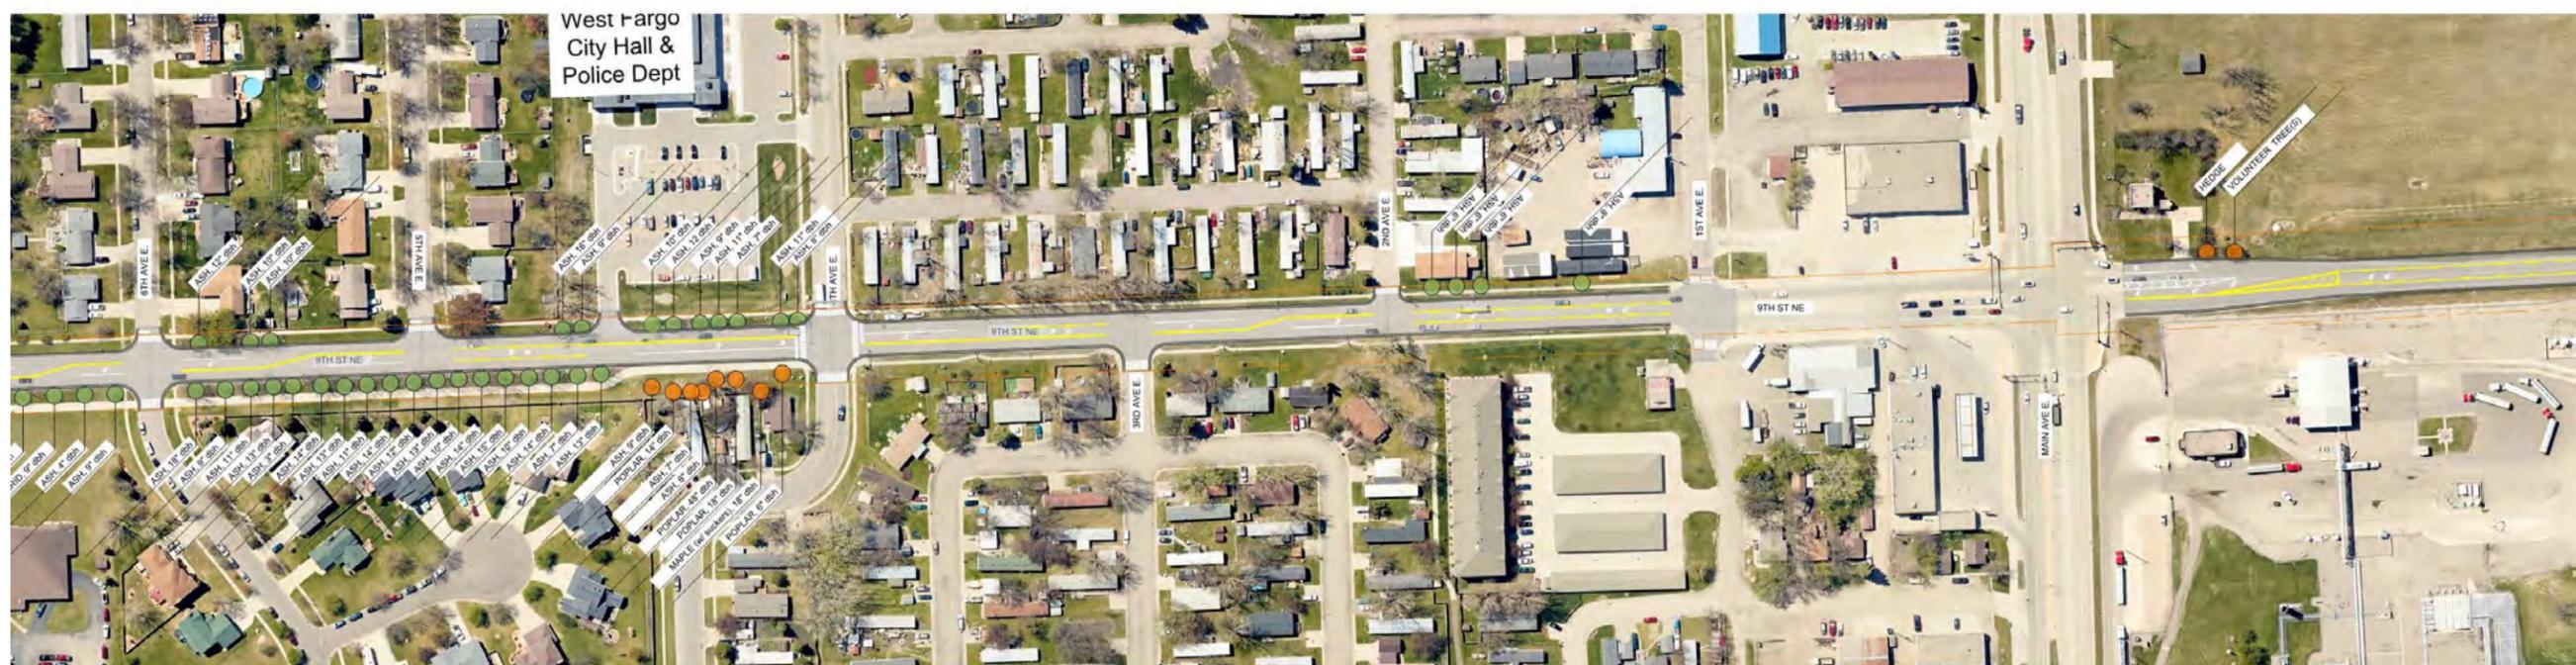
Figure 3.8: Trees along the 9th Street Corridor

Ash make up 81 of the 94 street trees in the study corridor. Ash were very good street trees due to their suitability to our soils, climate and urban environmental conditions, and were commonly utilized as the replacement tree for the commonly planted American Elm street tree from the 70's until recently.

13TH AVE NE TO 6TH AVE E

6TH AVE E TO MAIN AVE E

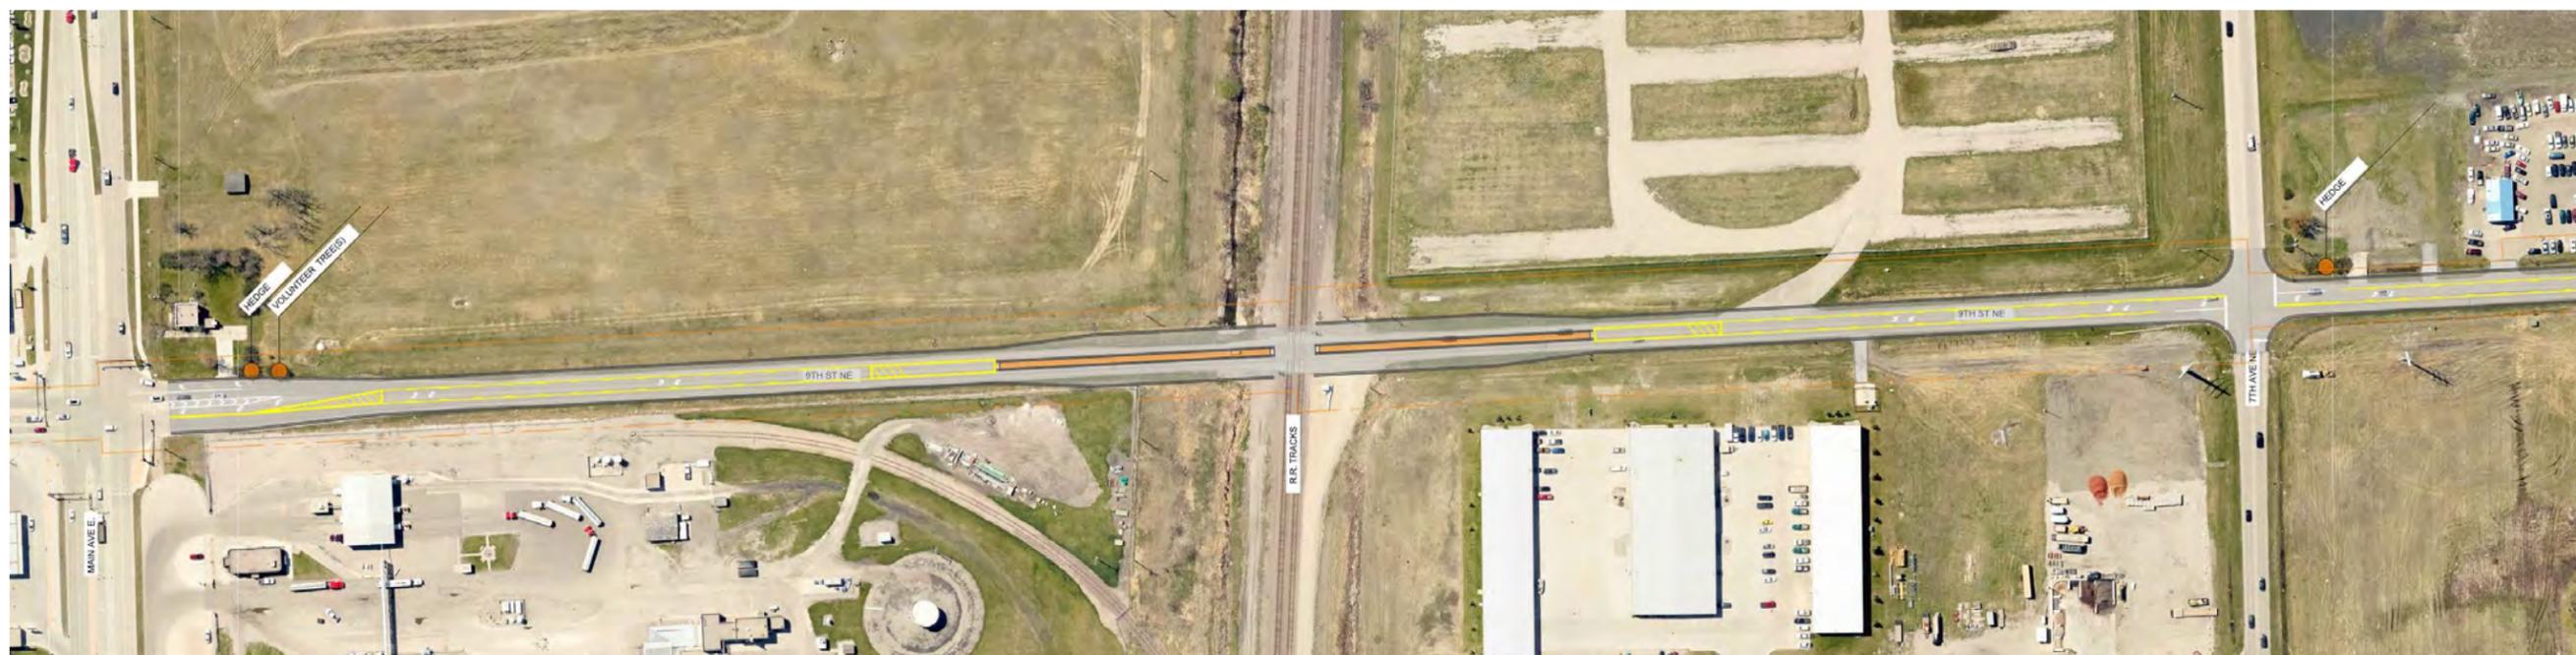
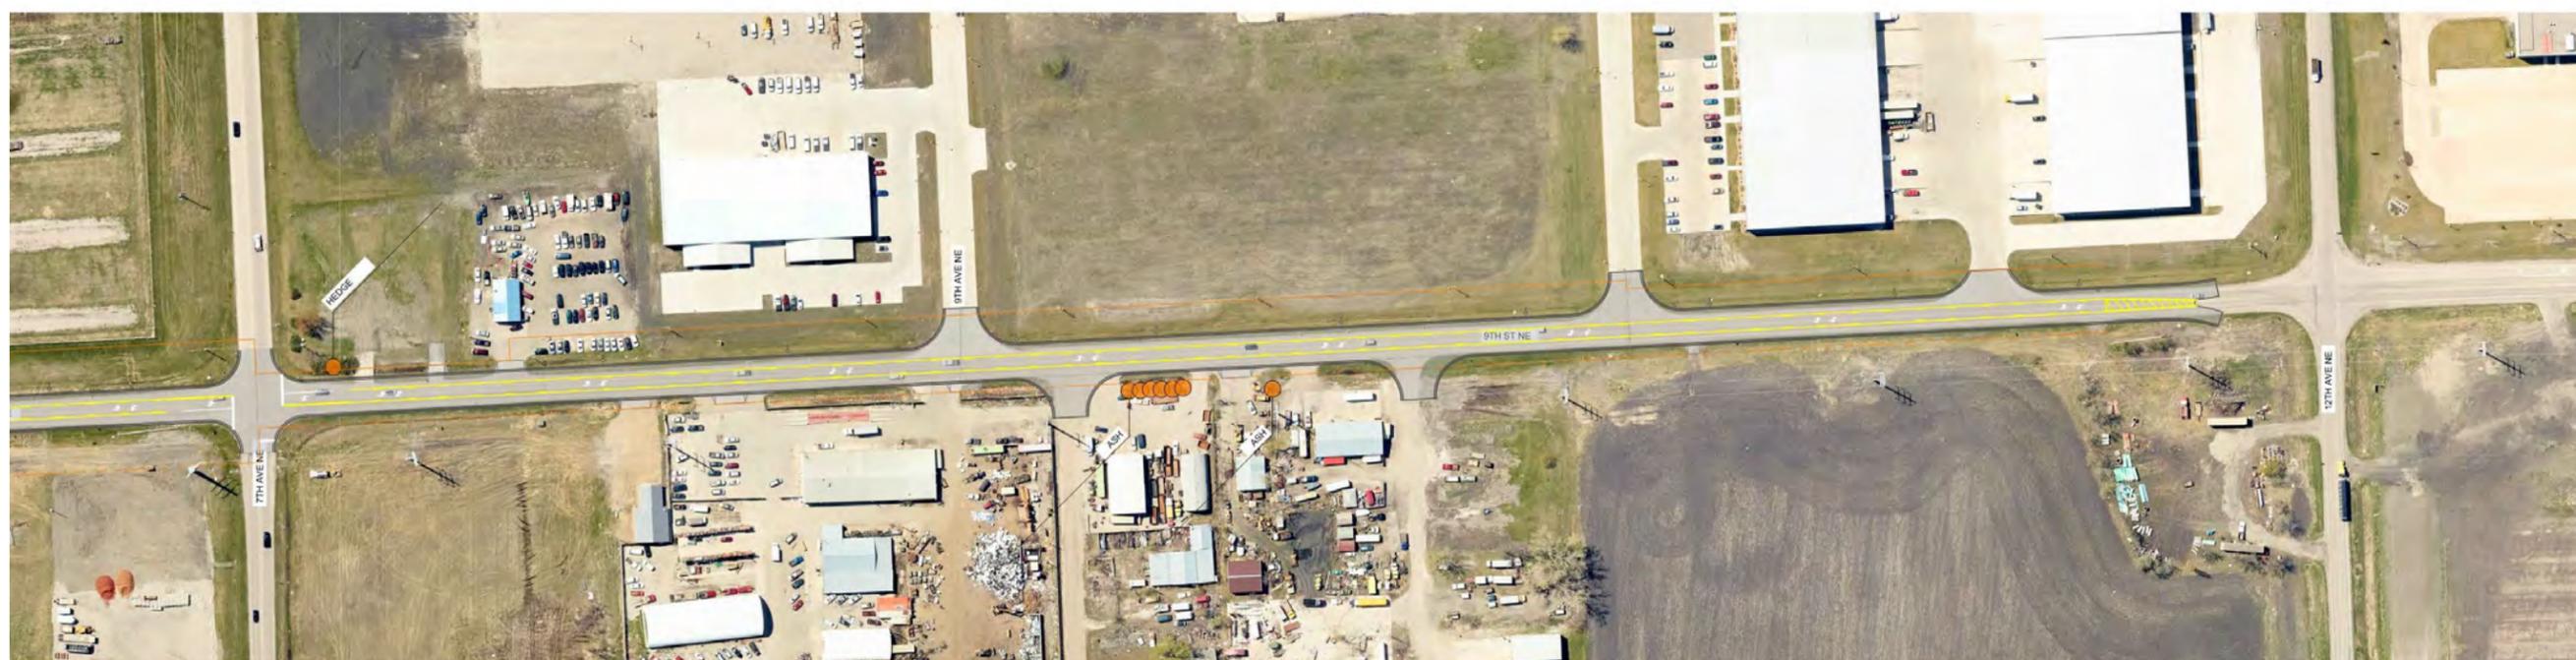
Figure 3.9: Trees along the 9th Street Corridor

MAIN AVE E TO 7TH AVE E

7TH AVE E TO 12TH AVE E

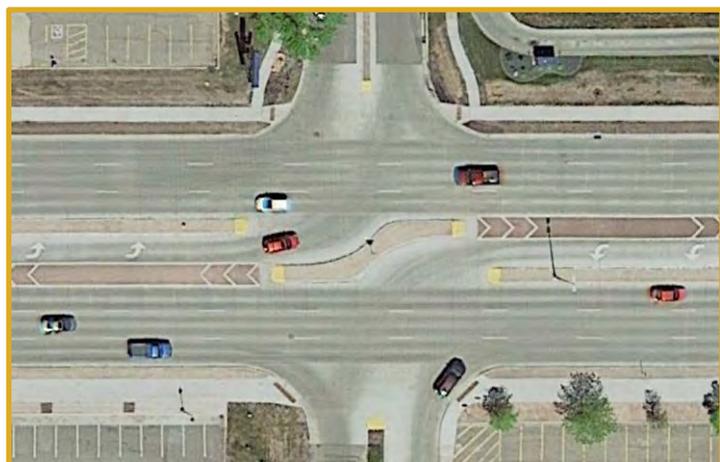
Example of ¾ Median Restricting Left Turns from Access Points

If accesses cannot be closed, an alternative to address safety concerns is to install a median barrier (full-median or ¾ median) so that traffic coming out of these access points are not making left turns across multiple lanes of traffic. An installation of some type of median would cause traffic to divert to other intersections where there are fewer turning conflicts.

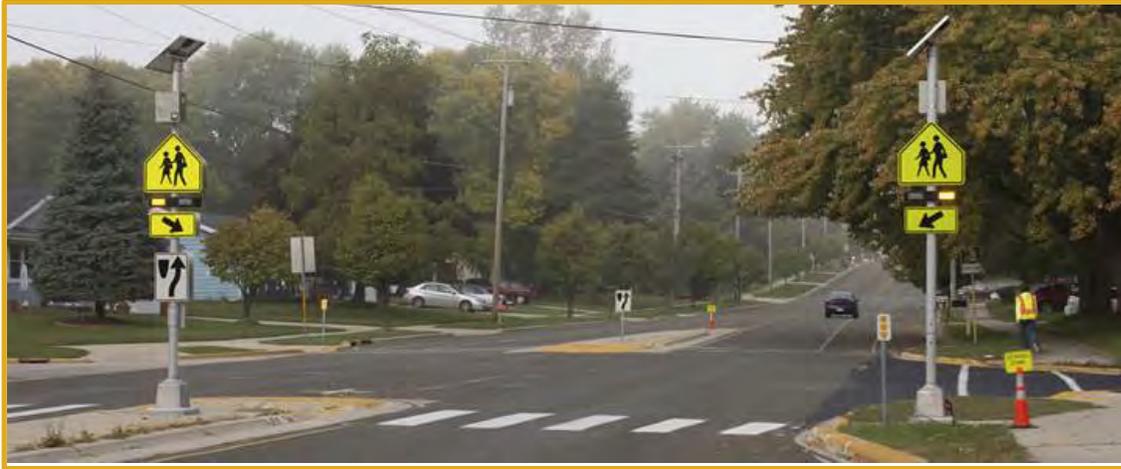
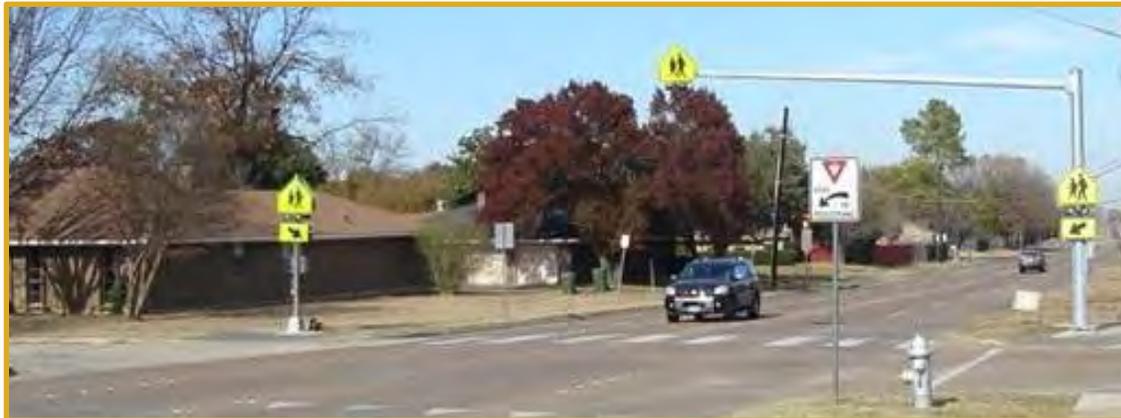
RRFBs are user-activated amber LED lights that attach to pedestrian warning signs and use an irregular flash pattern similar to emergency vehicles. Additional signs and markings can be used to increase the effectiveness of these systems. Previous national studies have shown motorists yielding to pedestrians 88 percent of the time with the activation of a four-beacon system (two beacons and a sign on each side of the crossing). These signs and flashers can also be mast-arm mounted over the roadway for additional visibility.

To address pedestrian safety concerns at 10th Avenue East and 8th Avenue East, a Rectangular Rapid Flashing Beacon (RRFB) would help facilitate the large number of pedestrians during the school year. These devices can replace the existing LED flashing signs in the same location, or be mast-arm mounted over the roadway. The cost of mast arms is not included in the estimated cost. If a traffic signal is warranted at 10th Avenue East in the future, it would be a preferred alternative. These options are alternatives 1D1, 1D2, and 1F.

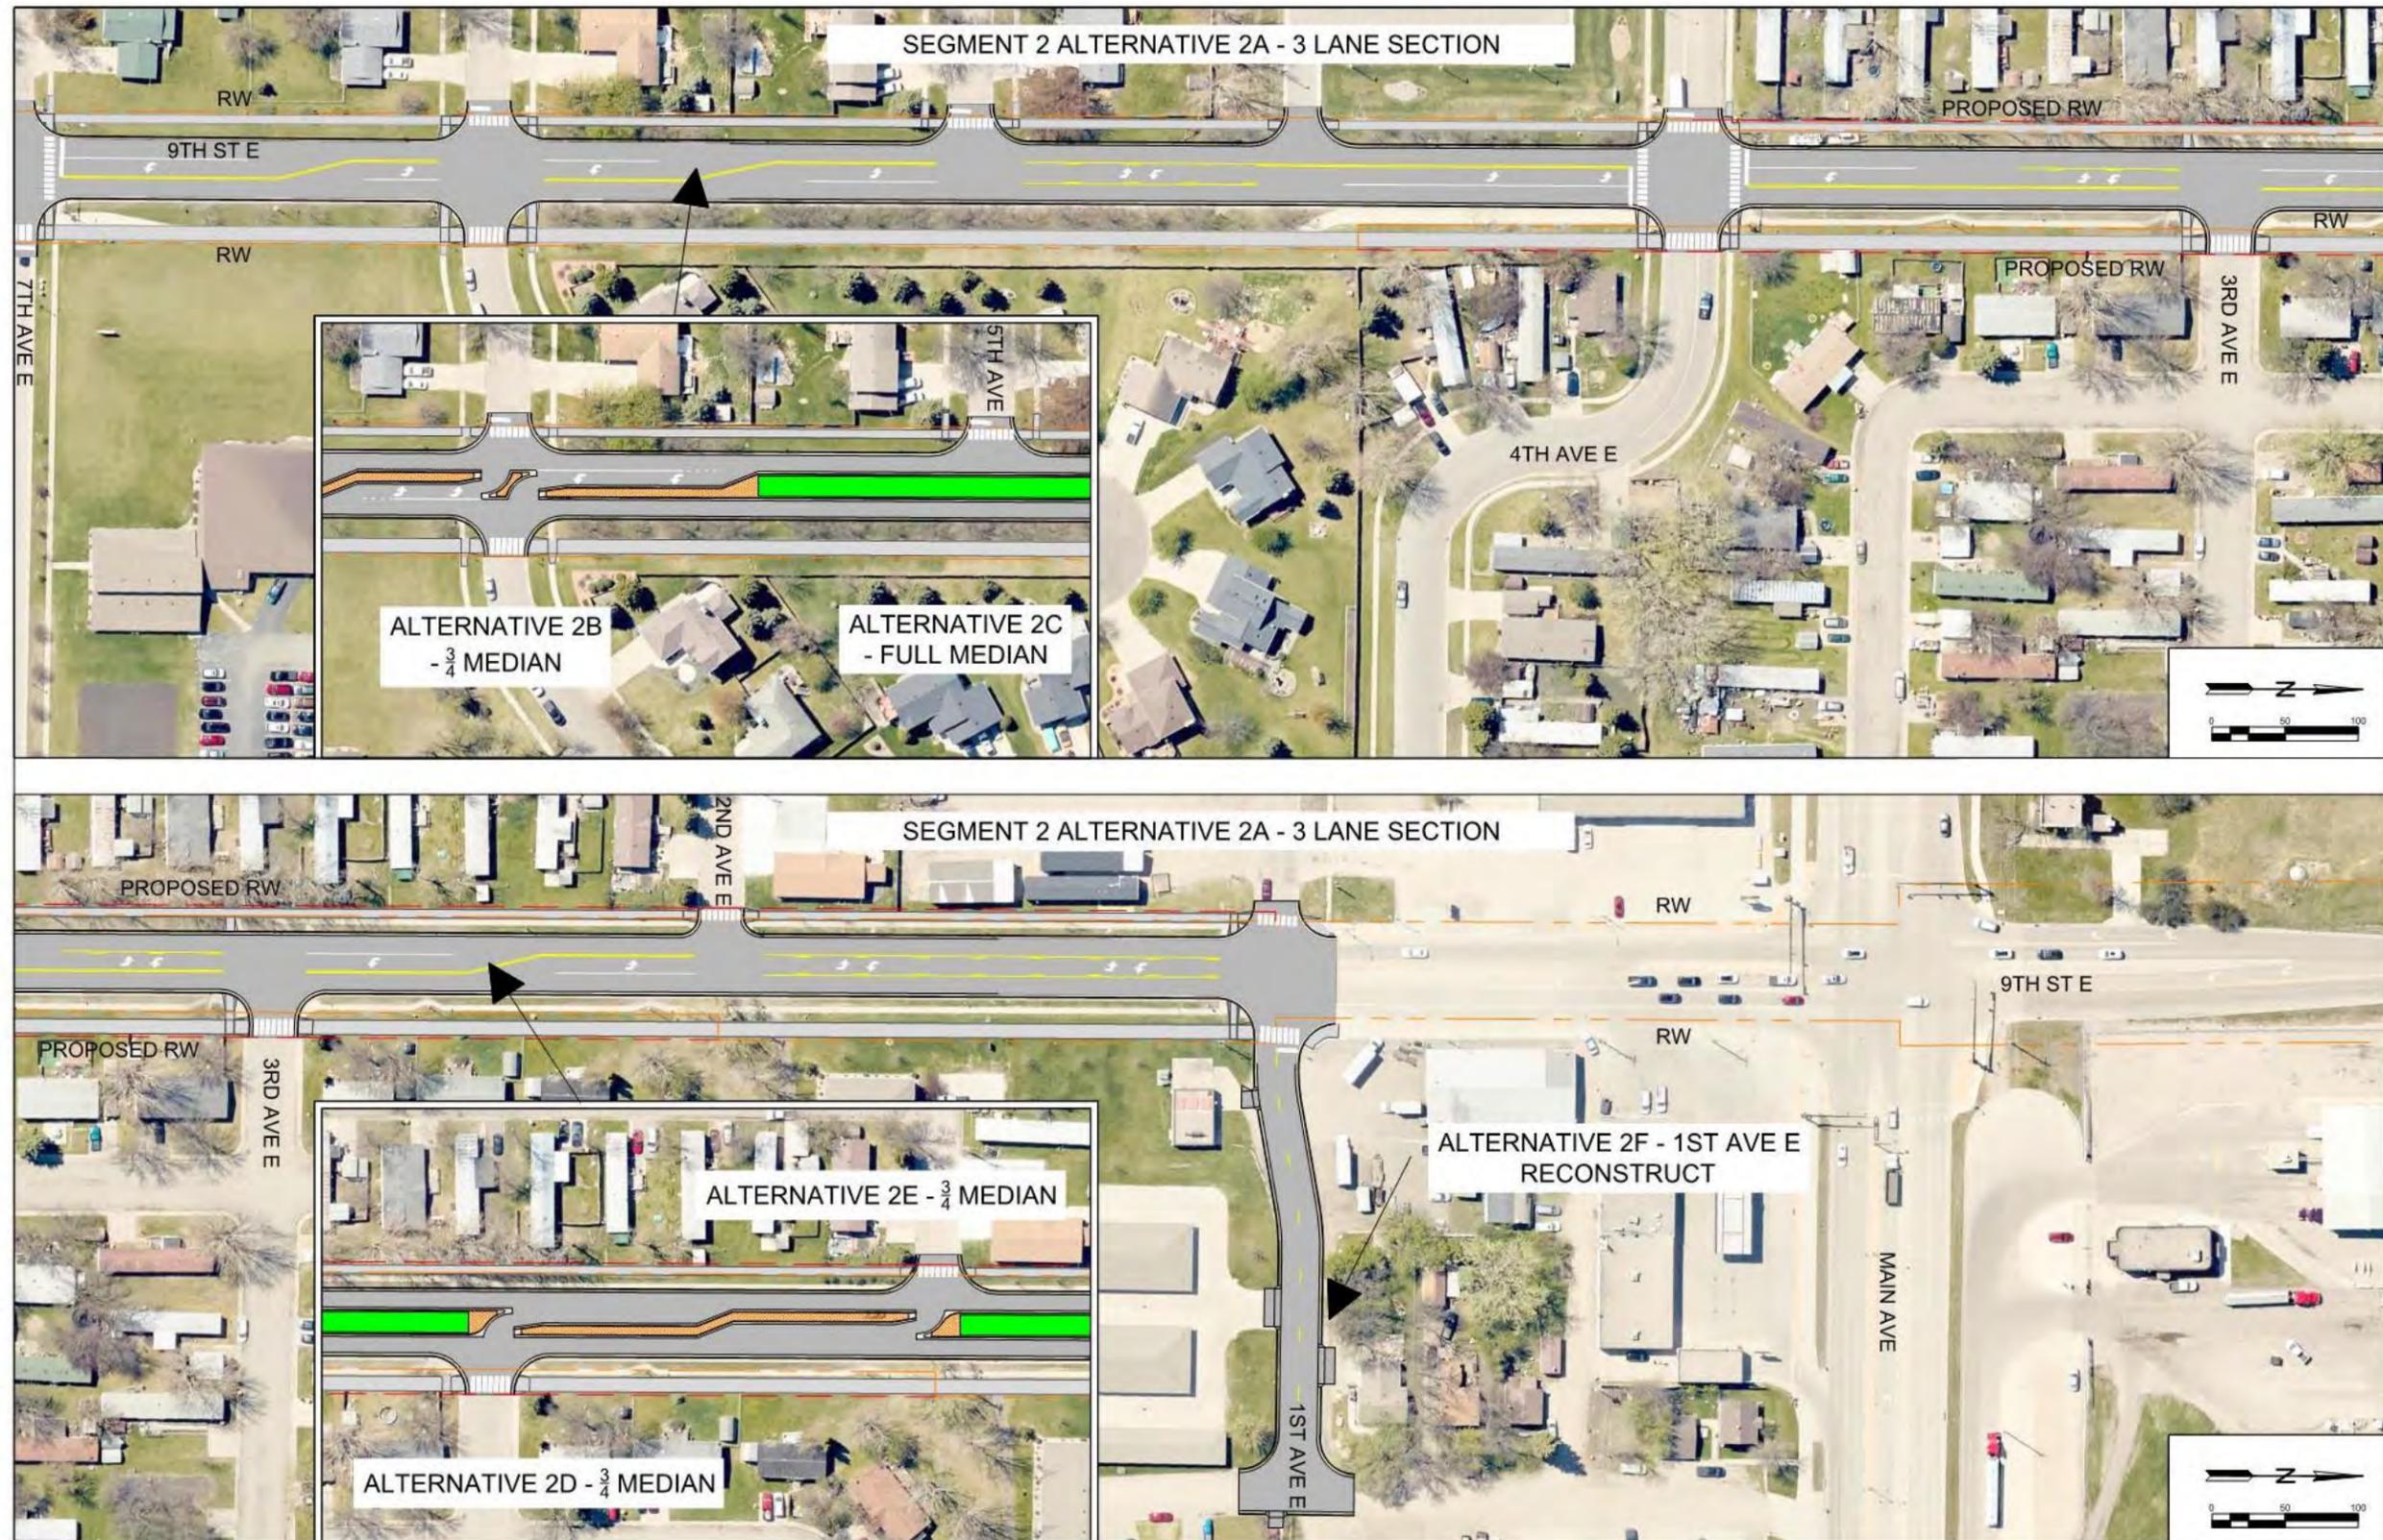
Figure 6.4: Segment 2 Proposed Alternatives

2E: ¾ Median at 2 nd Ave East and 9 th Street Intersection <i>Figure 11</i>	Safety, Access Management	\$3,500	Medium: Restricts left turns onto 9 th Street from 2 nd Avenue East, Extend Road Width	Not Preferred
2F: 1 st Avenue East Reconstruction <i>Figure 11</i>	Traffic Operations and Roadway Geometrics	\$210,000	Low: Realign 1 st Ave East to line up with intersection, install curb and gutter and define East Intersection	Preferred – Mid Range

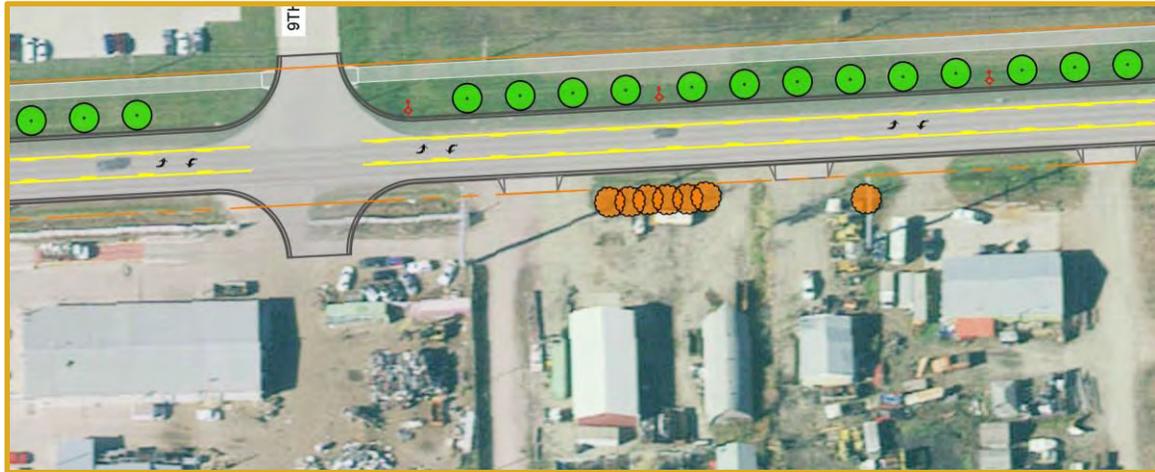
Figure 6.14: Boulevard trees are not proposed where they may conflict with established long-term existing usage of the site.

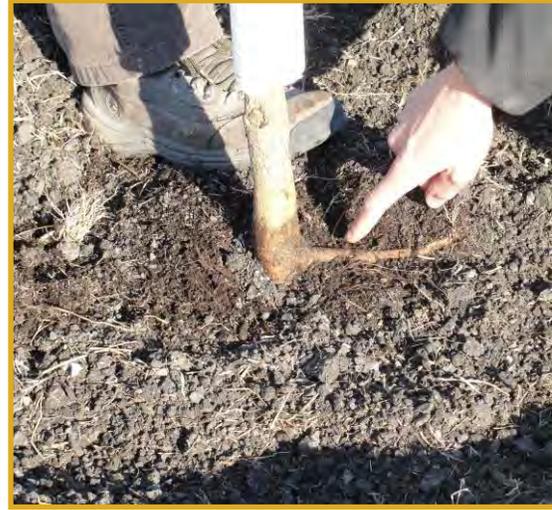
Flare root is exposed within containerized tree.

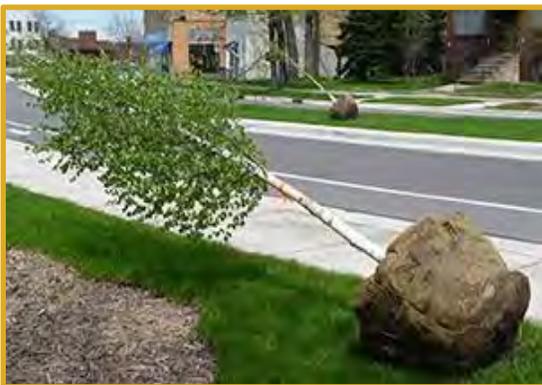
Tree is planted with flare root at-grade.

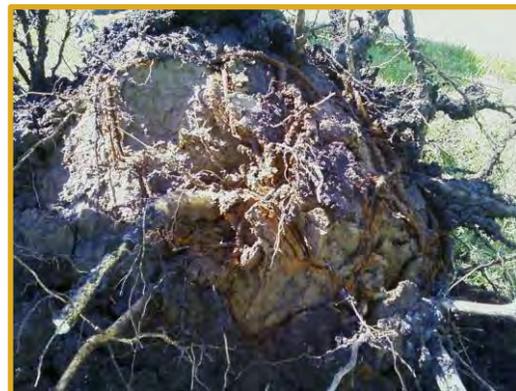
Balled and Burlapped tree. Entire wire basket and burlap should be removed at planting.

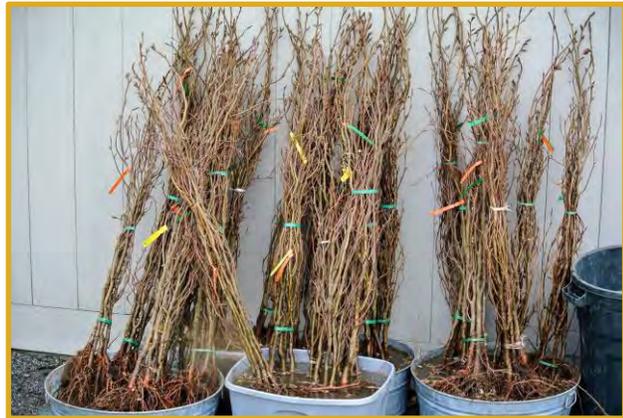
Bare-Root tree requires special handling until planting. Determining planting depth is obvious with flare root evident.
