To: Michael Maddox
Fargo-Moorhead Metro COG

Subject: US 10/75 Corridor Study – Existing Conditions Technical Memorandum

Introduction

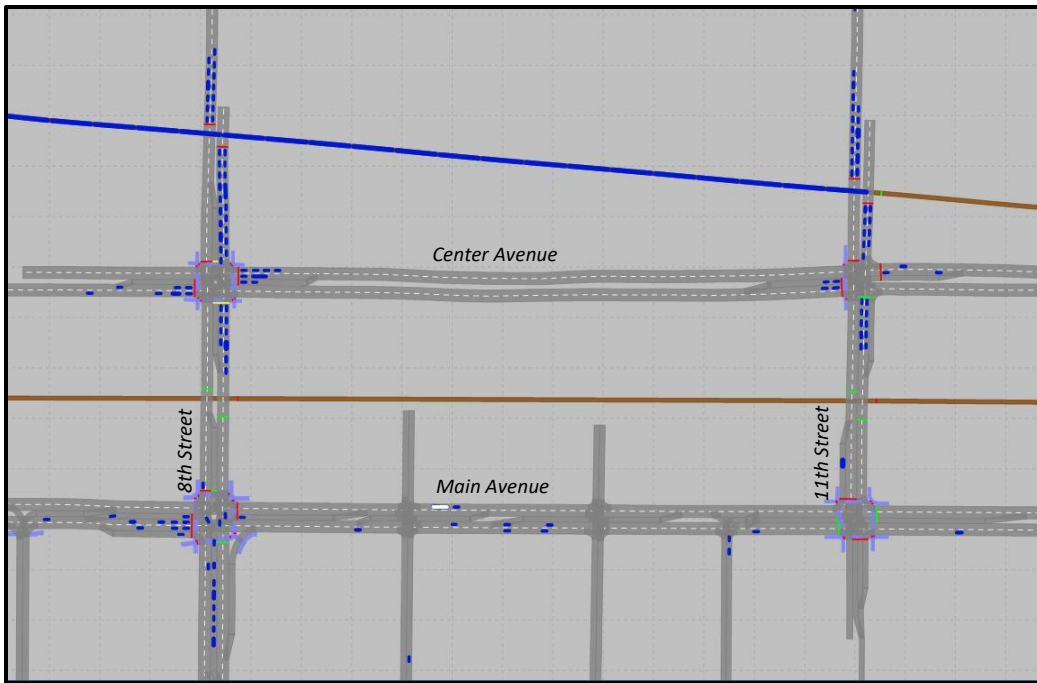
Figure 3. Train Operations During the PM Peak Hour - Prosper Line Train Queuing

- Typical traffic operations during a train event for the Prosper Line and the KO Line are illustrated in Figure 3 and Figure 4, respectively.

- Generally during train events, queuing will extend into the adjacent intersection; after train events (i.e. the gate arms raise), a majority of vehicles are able to clear in one signal cycle, with a portion of vehicles taking two cycles to clear.

- Trains along the Prosper Line were observed to travel through the study area for up to 13 minutes.
- During train events, vehicles were observed to reroute through the study area to avoid the train. While train events were analyzed, the capacity analysis is not able to account for dynamic travel pattern shifts that occur during these events. The traffic modeling software is not able to recognize these dynamic travel pattern changes but does account for current travel patterns collected and observed.

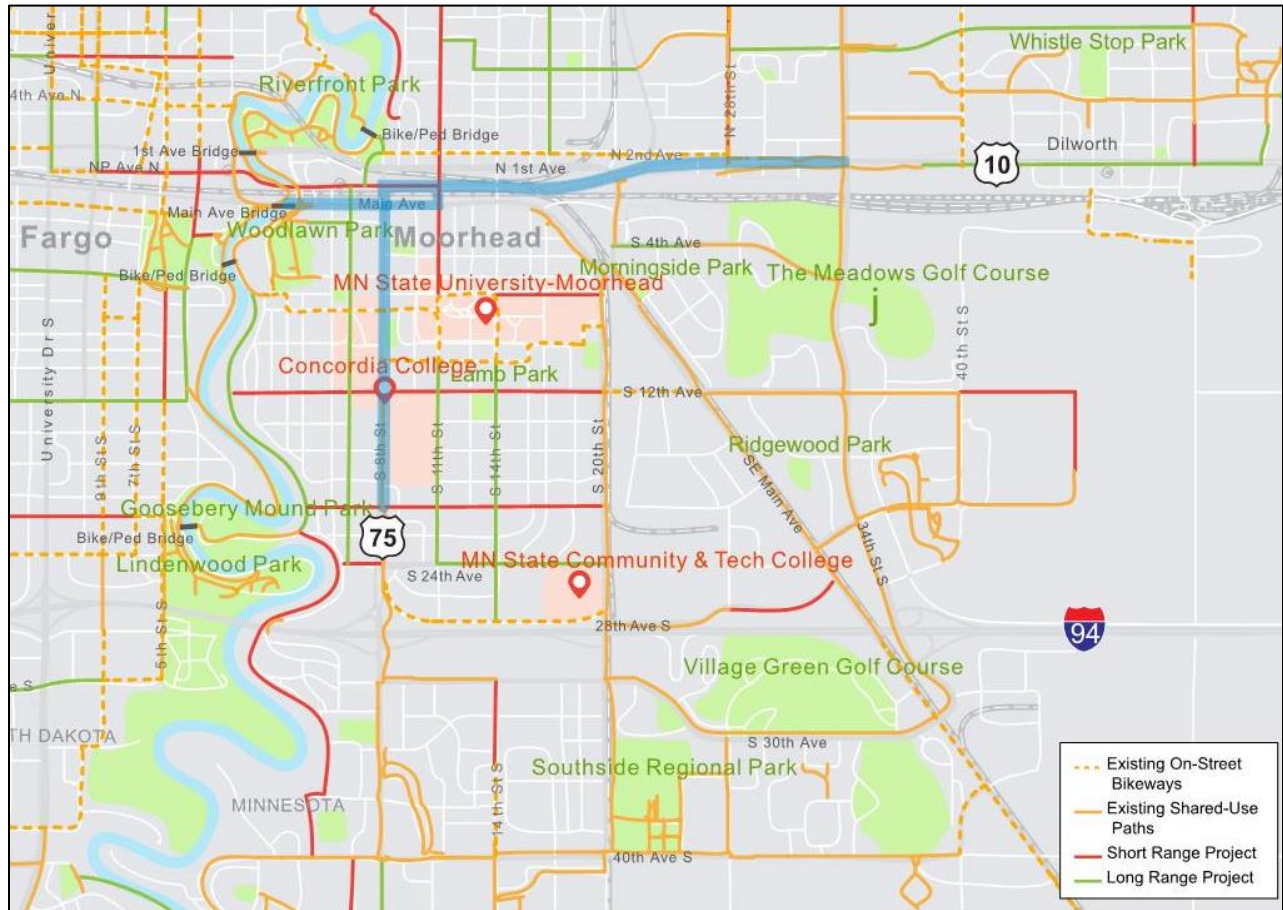
Figure 8. Existing and Planned Bikeways

The existing pedestrian/bicyclist facilities along the study corridors were inventoried and summarized in Table 6. There is an existing gap in the pedestrian/bicycle system along Center Avenue (US 10/75) between the 11th Street and 21st Street/1st Avenue intersections. Bicycle facilities (i.e. shared use trails) are provided along 8th Street (US 75) south of 12th Avenue and along Center Avenue (US 10) east of 27th Street, however no other existing or planned trails are provided elsewhere along the study corridor. The existing and planning pedestrian/bicyclist network is illustrated in Figure 8.

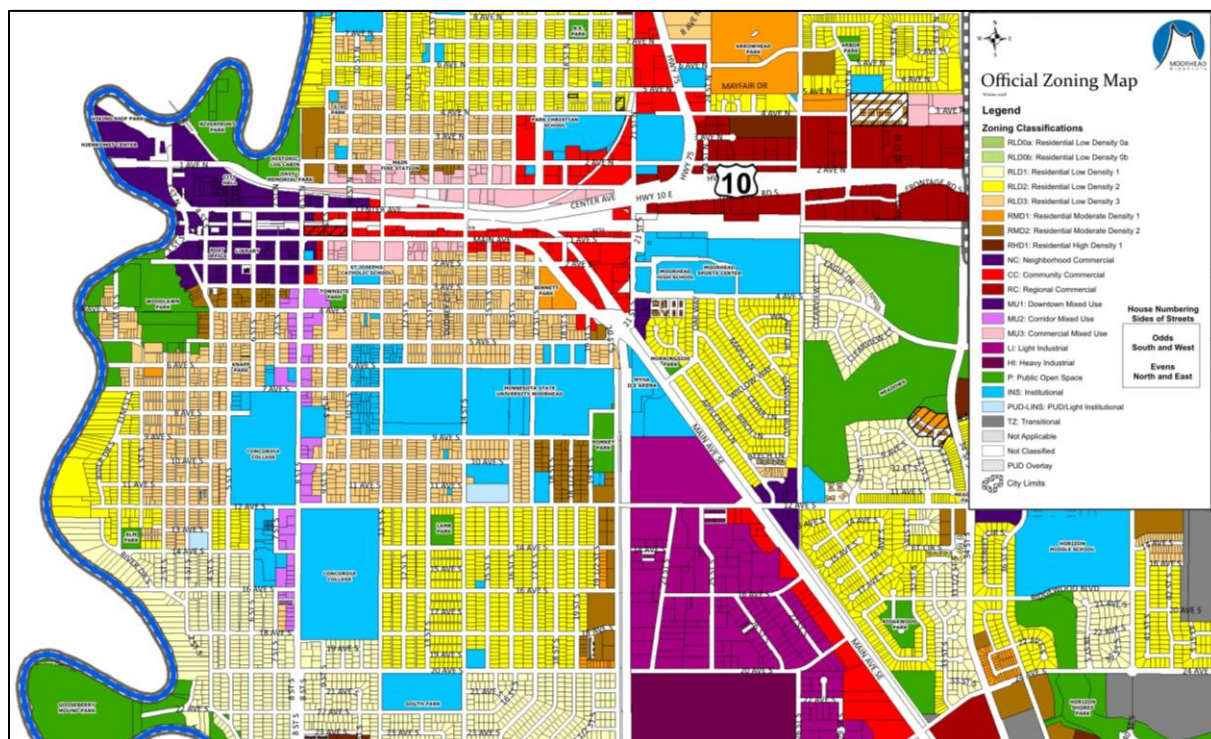
Figure 10. Existing Land Use Zoning Map

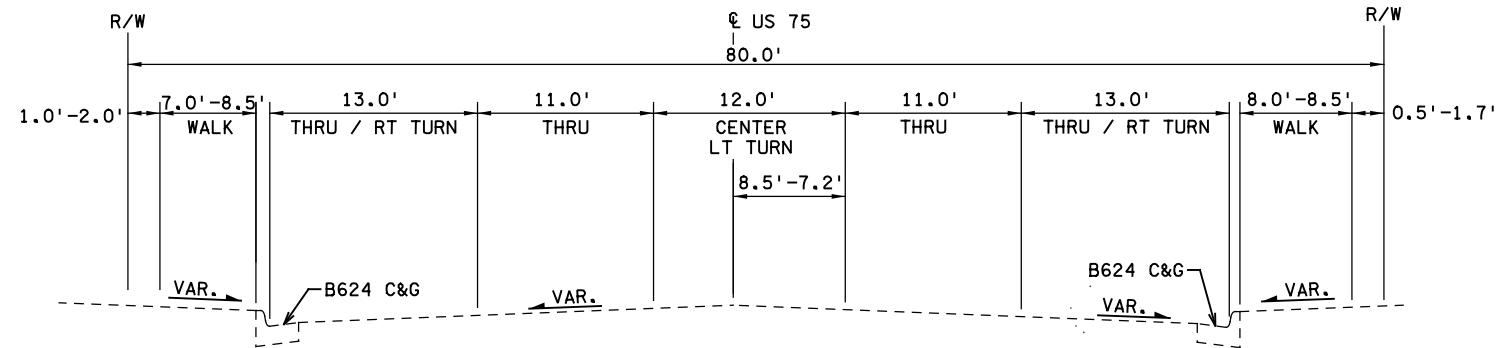
US 75
4TH AVENUE S TO 2ND AVENUE S

NOTES:
① 0'-2' SPECIAL SURFACE TREATMENT STAMPED & COLORED VARIABLE SLOPE

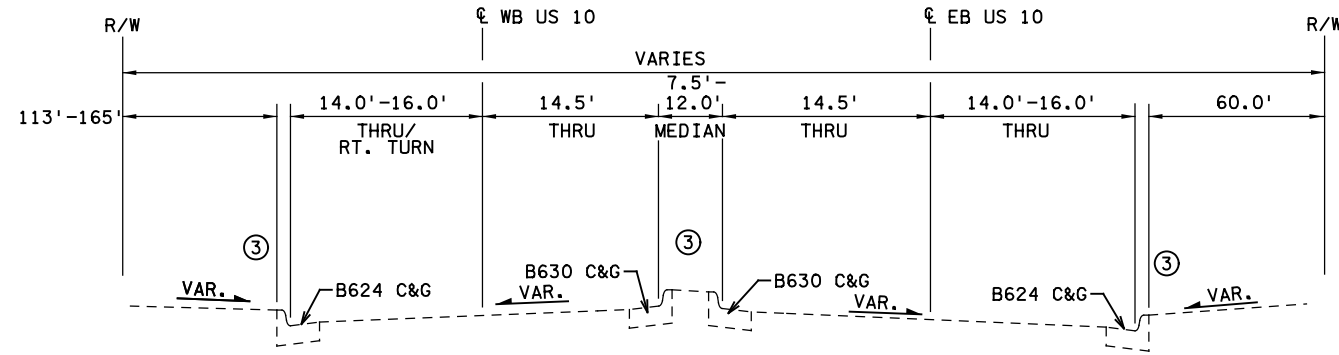
US 10
EAST OF 14TH STREET S TO EAST OF RR BRIDGE

③ GUARDRAIL LOCATIONS
NEAR RR BRIDGE
